## XSTRATA NICKEL, THAYER LINDSLEY MINE, SUDBURY, ON

### AF-D ARMOUR GUARD

<b>PROJECT:</b>	1490 Ore Pass Rehabilitation Xstrata Nickel, Thayer Lindsley Mine Sudbury, ON
<b>SPECIFIER / CONTRACTOR:</b>	Xstrata Nickel Sudbury, ON
<b>PRODUCT:</b>	AF-D Armour Guard
<b>QUANTITY:</b>	150 m <sup>3</sup> (5300 ft <sup>3</sup> )
<b>COMPLETION:</b>	Winter 2001

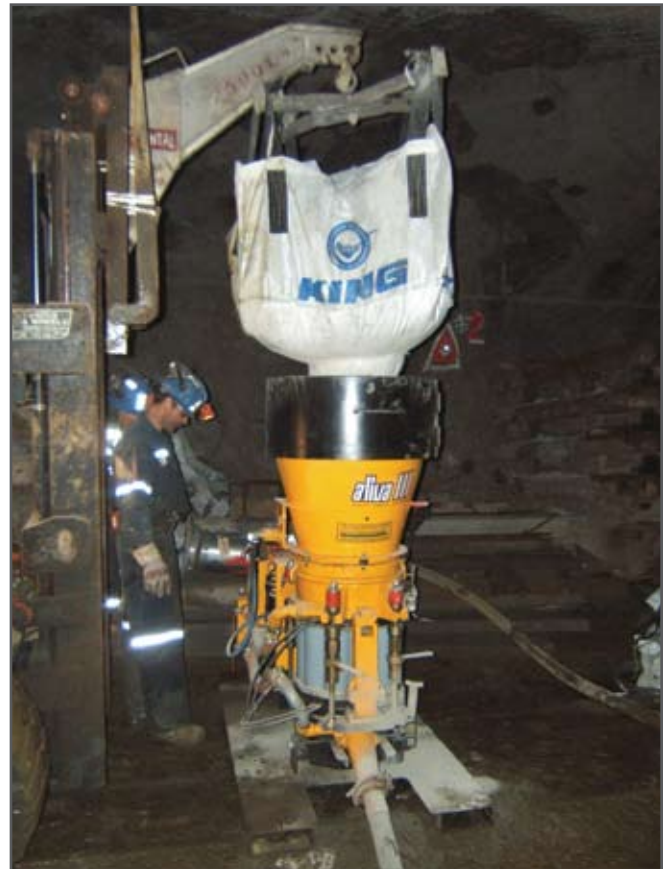
In July 2002, a camera was lowered into the ore pass to verify the condition of the walls and the extent of liner material loss. At the time the camera survey was conducted, no cable bolt strands were exposed beyond the 100-150 mm (4-6 inches) layer of impact/abrasion-resistant shotcrete.

Through its specialty, high performance cement matrix, AF-D Armour Guard offers resistance to abrasion caused by rolling muck and the addition of steel fibres adds resistance to impact. The rehabilitation of the 1490 ore pass was completed in December 2001. In January 2002, the mine re-commissioned the ore pass.

Since the rehab work was completed, sloughing of the ore pass has been eliminated in the vicinity of the grizzly and this has enabled the mine to return to normal production levels.
